METALLOGRAPHIC AND FRACTOGRAPHIC EXAMINATION

OF 7079 ALUMINUM ALLOY TEST SPECIMENS

THE BOEING COMPANY

**Prepared under Contract No. NAS 1-6474
by
THE BOEING COMPANY
Renton, Washington
for
NATIONAL AERONAUTICS AND SPACE ADMINISTRATION**

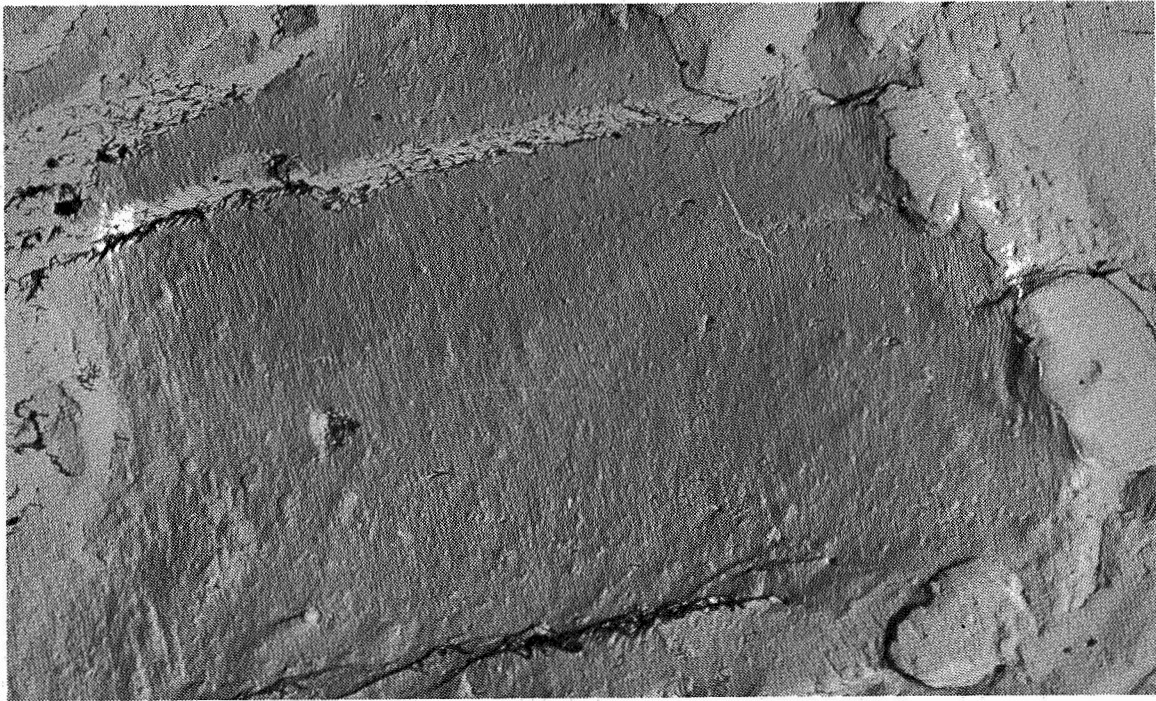
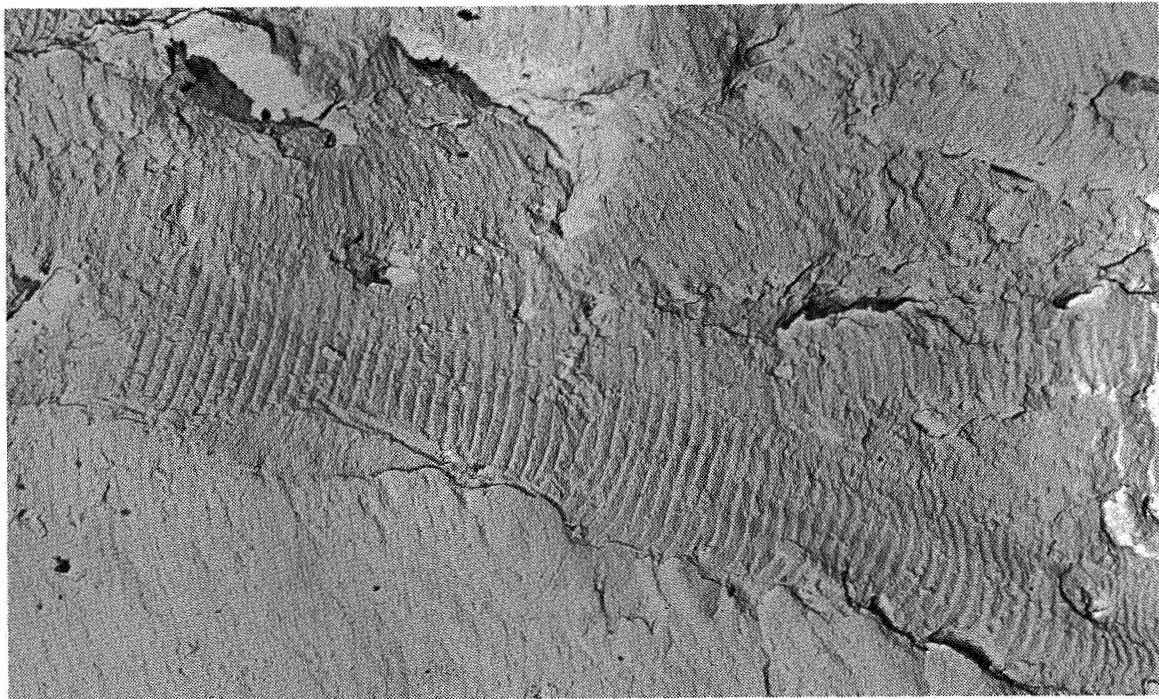
Figure 34. *Electron fractographic comparison of striation spacings under identical test conditions, $2a = 1.0$ inch (Magnification 3200 X)*

Results: Profiles of the fractures are shown in figure 33. An examination of the fracture surface at six crack lengths verified the marked difference in crack propagation rates as indicated by the striation spacing. Typical fractographic examples showing the relative spacing are presented in figure 34. No metallurgical variation that could account for the effect was observed.

In thicker material (essentially plane strain), the average size of the plastic zone in front of a crack is smaller than for thin material (essentially plane stress) at the same K level. It has been proposed that the mechanical fatigue damage accumulating over smaller average volumes will produce cracking at higher rates. However, no explanation for the limitation of this effect to the wide panels is apparent.

Conclusions: The fatigue-crack-growth rates on a microscale reflect the macroscopic observations. No metallurgical variables account for this variation. A possible explanation for this effect involves the ratio of plane-strain-to-plane-stress conditions across the crack front.

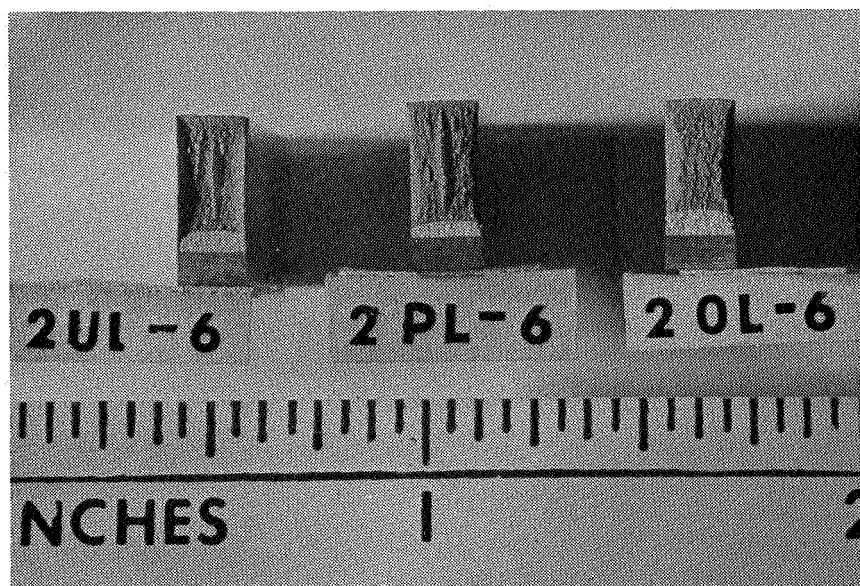
Figure 35. Macroscopic view of the fracture surface of precracked Charpy specimens

Results: The fractures are shown in figure 35. Sections through the fracture faces are shown in figures 36 and 37. No metallurgical or mechanical reasons for this difference in behavior were observed.

Conclusions: The reasons for this behavior were not determined.

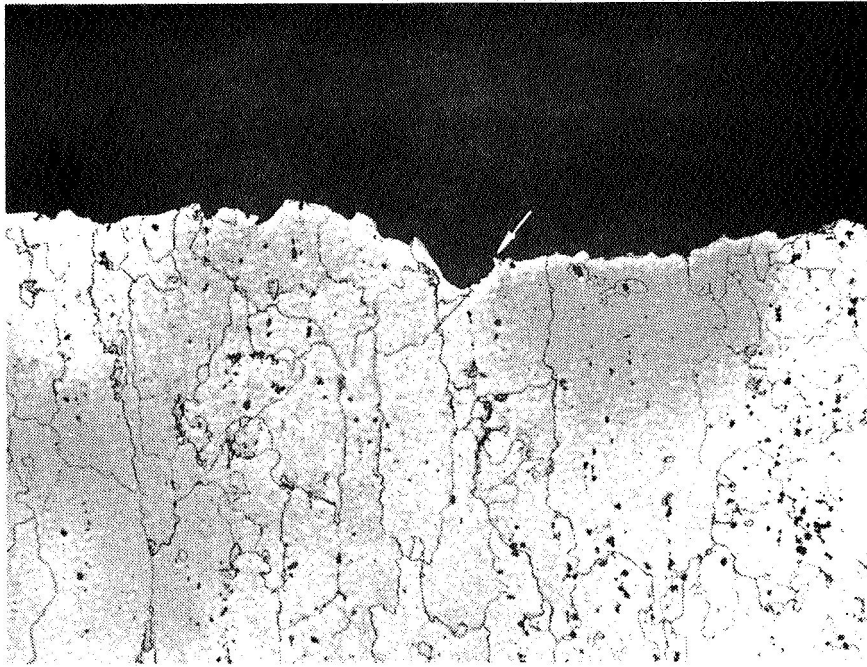
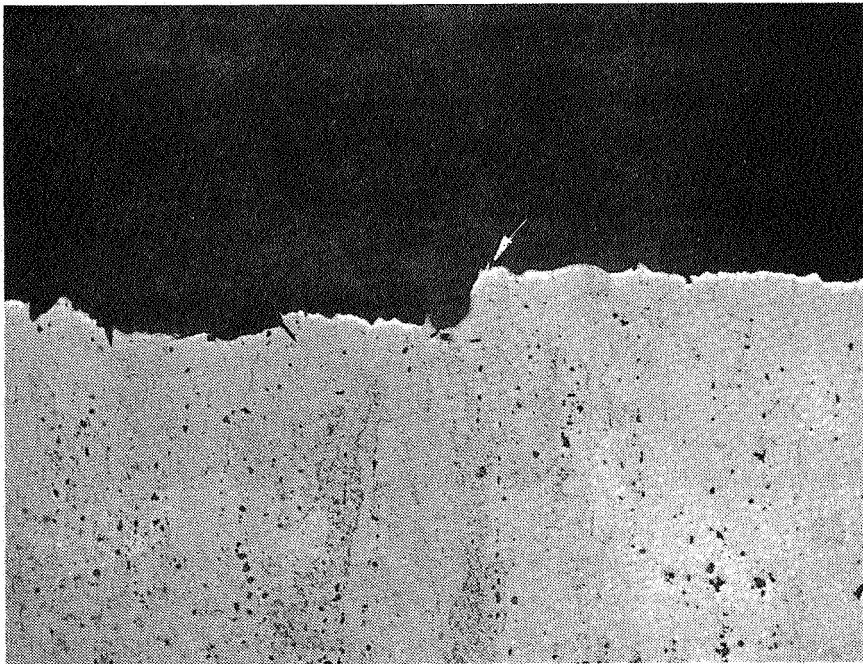
Figure 36. Fracture profile through precracked Charpy specimens (Magnification 100X)

NOTE: Arrow indicates interface between fatigue and fast fracture

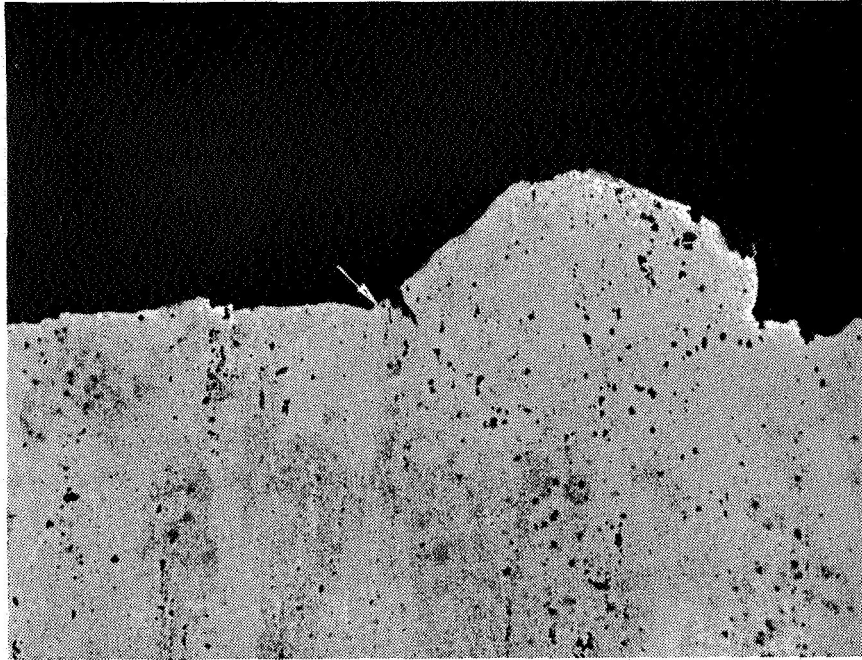
Figure 37. Fracture profile through overaged precracked Charpy specimens (Magnification 100X)

NOTE: Arrow indicates interface between fatigue and fast fracture
